# **AUTOMATED DATA COLLECTION FOR PAVEMENT CONDITION INDEX SURVEY**

Gregory D. Cline  
Naval Facilities Engineering Service Center  
[gregory.d.cline@navy.mil](mailto:gregory.d.cline@navy.mil)

Mohamed Y. Shahin and Jeffrey A. Burkhalter  
USA ERDC Construction Engineering Research Laboratory  
[mohamed.y.shahin@erdcl.usace.army.mil](mailto:mohamed.y.shahin@erdcl.usace.army.mil)

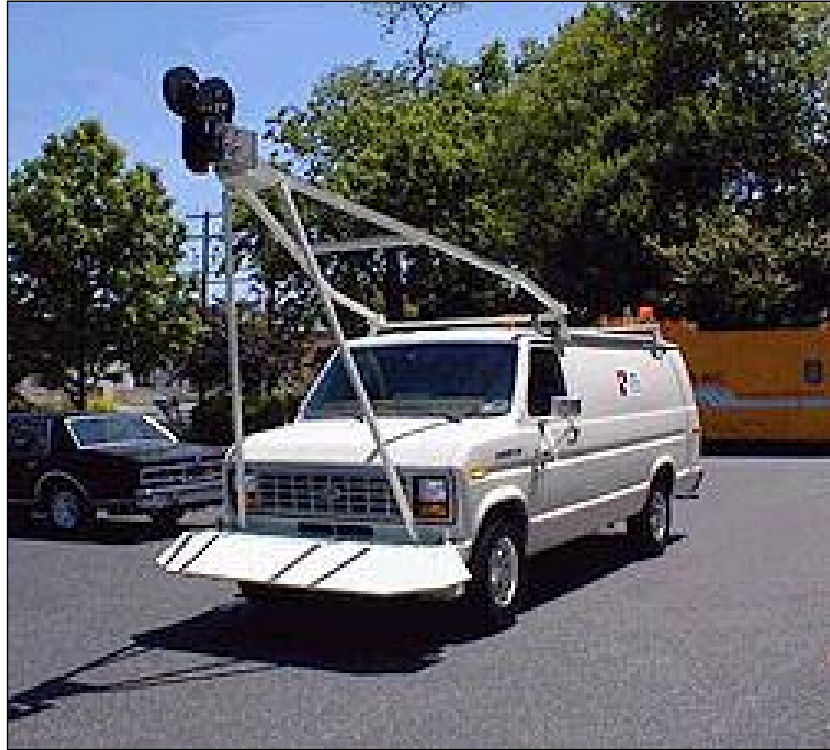
**FIGURE 2 Data collection vehicle for 35 mm analog continuous film technology.**

This system consists of a boom-mounted, 35 mm slit camera, electronic controller, and custom illumination system. The data collection vehicle is shown in Figure 2. The electronic controller synchronizes the film speed to the speed of the vehicle so that there is no loss in resolution with changes in vehicle speed. The illumination system consists of an array of halogen lights mounted in a custom bumper. This system allows control of the angle and degree of illumination on the pavement surface for maximum resolution. The images collected are at a 1:200 scale. These images are analyzed to determine the types, severity, and extent of pavement distress at the workstations located at CGH. A workstation is shown in Figure 3.

This system also uses a pulse camera, which photographs the transverse profile of the roadway at selected intervals to determine rut depth and shoulder drop-off. The pulse camera is synchronized with a hairline strobe projector mounted on the rear bumper and maintains a precision of  $\pm 2$  mm and is synchronized to the actual vehicle speed.

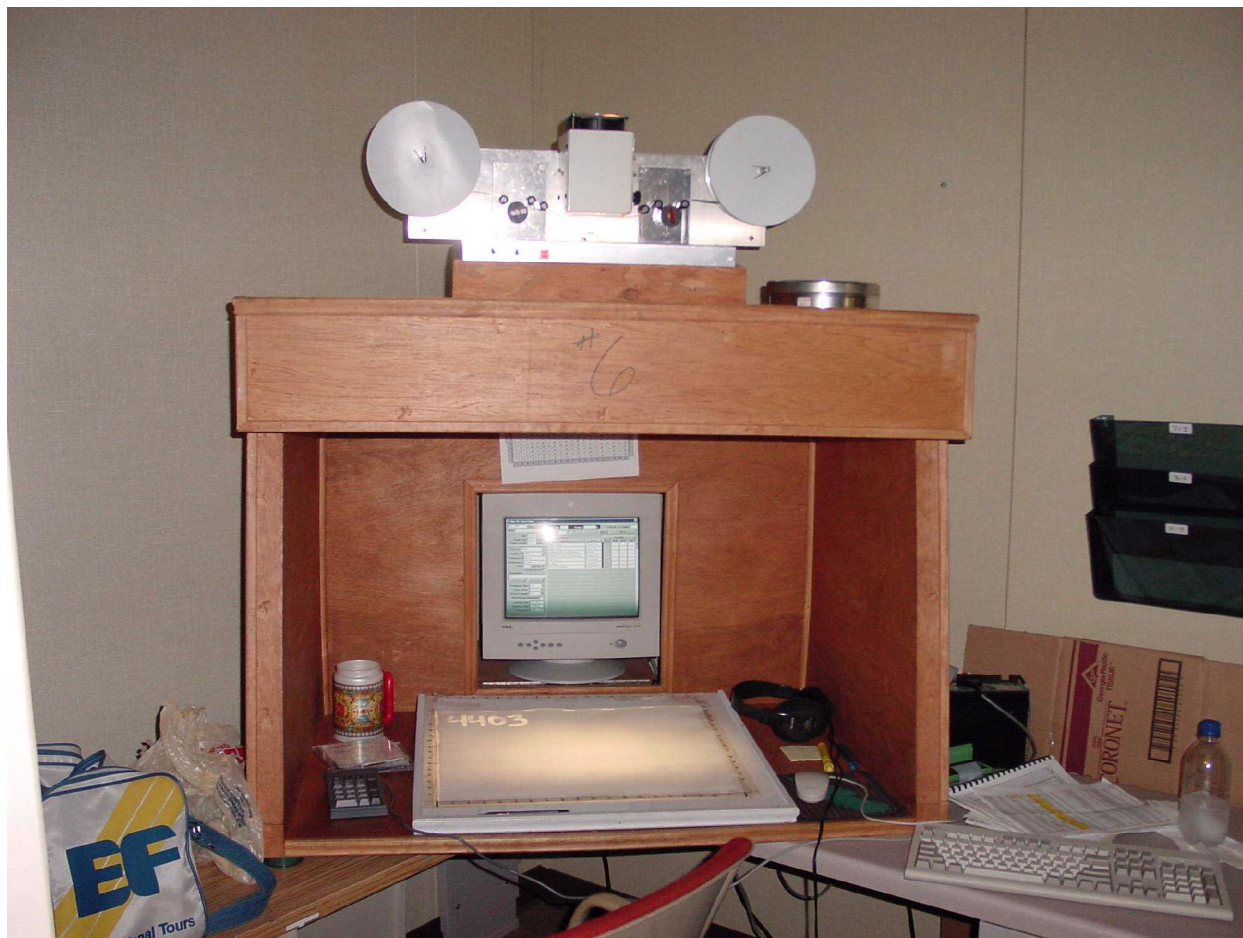
**FIGURE 3 Workstation for 35 mm analog continuous film technology.**

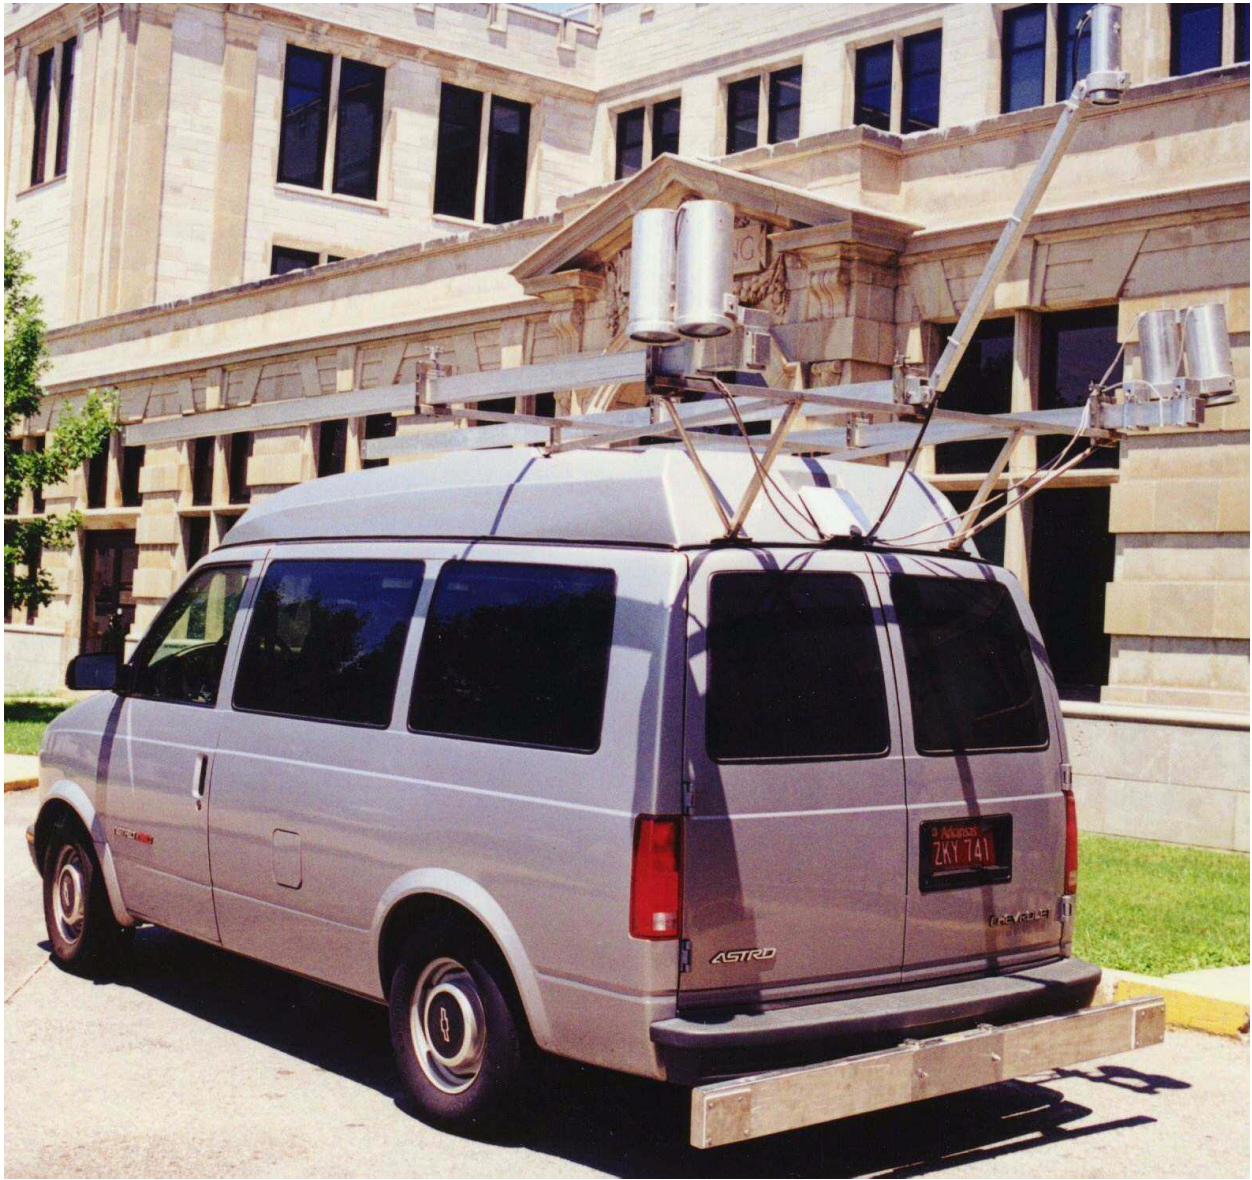
**FIGURE 4 Data collection vehicle for digital camera technology**

This technology uses a digital camera with strobe lighting. The imaging system collects full pavement width of 14 feet (4.3 meters) at the resolution of 1,300 x 1,024 pixel images in a continuous fashion. Data collection ranges from 1 to 60 miles per hour (1 to 100 kilometers per hour) and all images are stored in an onboard computer system. Images are generally collected at night using strobe lighting. Camera adjustments are made either manually or

automatically to ensure that high quality images are collected. Images are then stitched together (computer software package) to form a continuous image of the pavement surface. Image location is closely controlled through a highly accurate distance measuring instrument (DMI) and the use of global positioning. The data collection vehicle is shown in Figure 4.

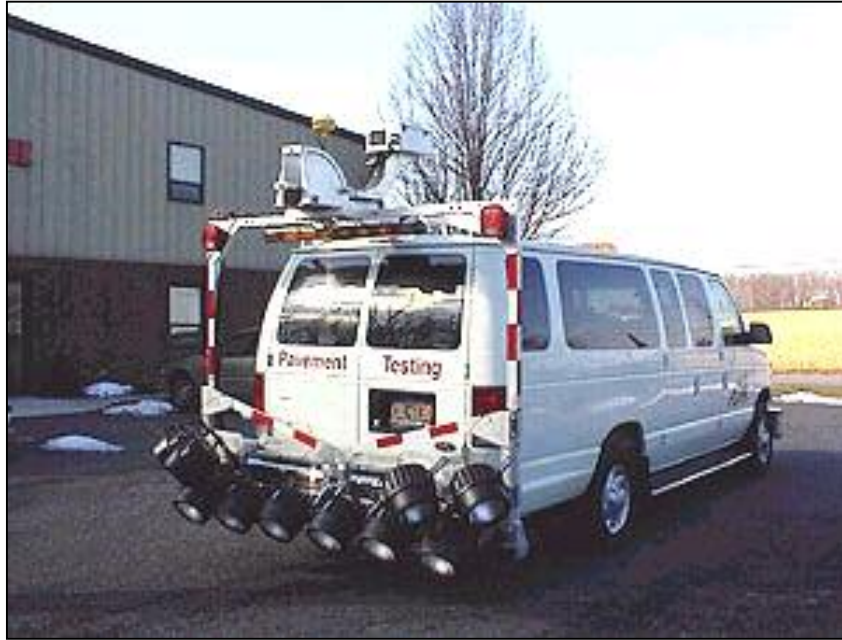
**FIGURE 6 Data collection vehicle for digital line scan imaging technology.**

The digital system uses state-of-the-art digital imaging technology to collect continuous, high-resolution images of the pavement surface. The digital imaging system consists of a 2,000-pixel digital line scan camera, illumination system, and computerized controller. The line scan camera is set to cover a width of 14.5 feet (4.4 meters). Data collection speed ranges from 1 to 60 miles per hour (1 to 100 kilometers per hour) and all images are stored in an onboard computer system. Images are generally collected at night using an illumination system, which consists of an array of halogen lights mounted in a custom bumper. The data collection vehicle is shown in Figure 6.

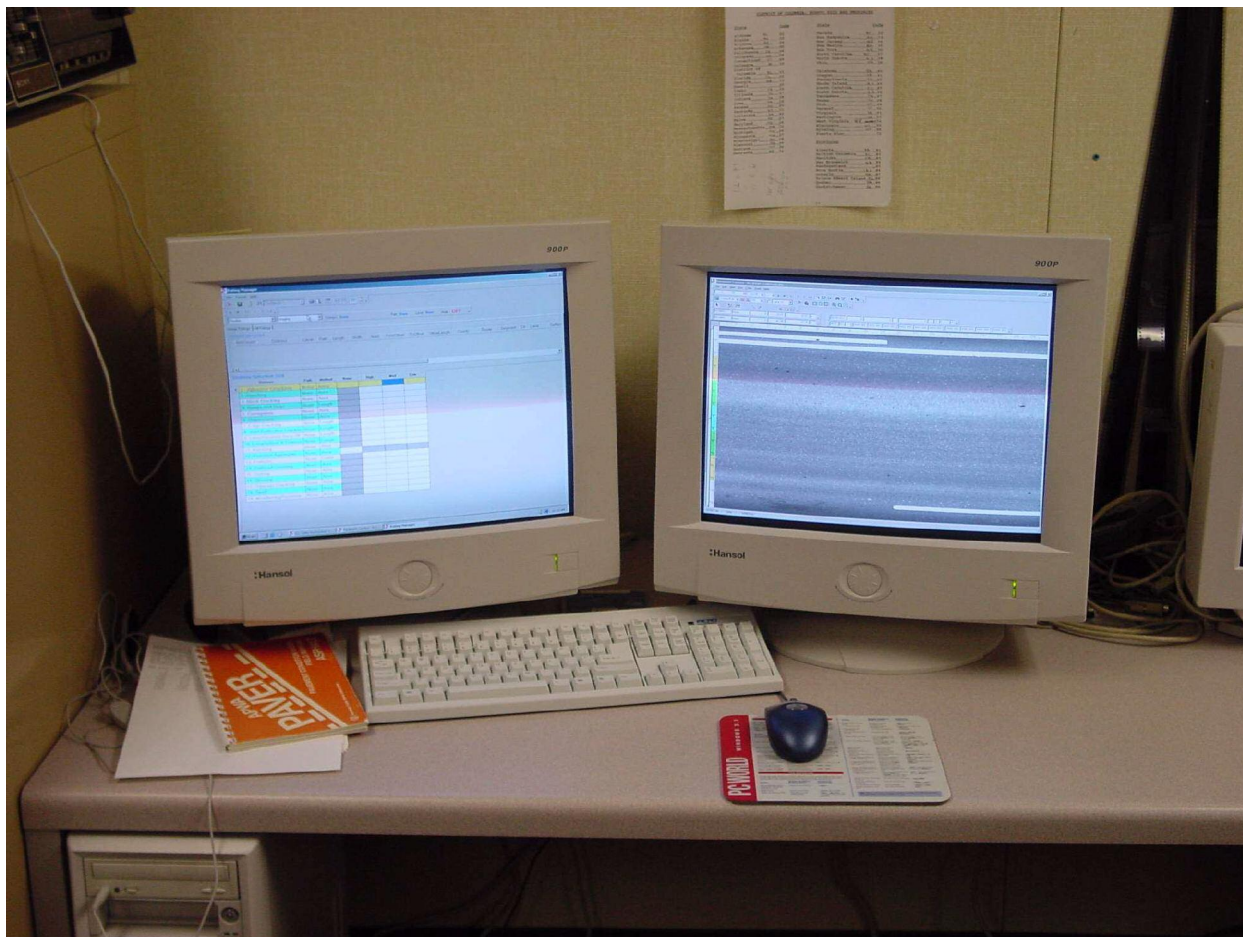
**FIGURE 7** Workstation for digital line scan imaging technology.

Data processing is completed in the office. Images are analyzed to determine the types, severity, and extent of pavement distress at the workstations located at CGH. A workstation is shown in Figure 7. This system also uses a pulse camera, which photographs the transverse profile of the roadway at selected intervals to determine rut depth and shoulder drop-off. The pulse camera is synchronized with a hairline strobe projector mounted on the rear bumper and maintains a precision of  $\pm 2$  mm and is synchronized to the actual vehicle speed.
